Firebrand Protection as the Key Design Element for Structure Survival during Catastrophic Wildland Fires

Joseph W. Mitchell¹ & Oren Patashnik²

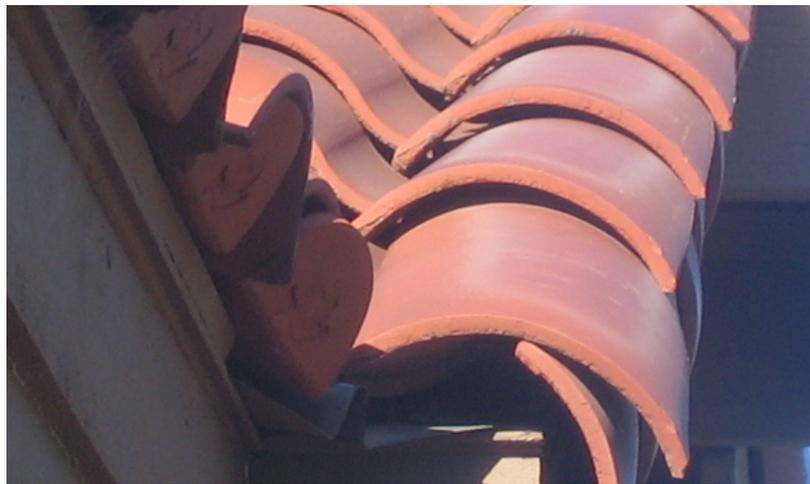
Figure 1. Curved Tile Roof

This figure illustrates the firebrand vulnerabilities introduced by poor construction or maintenance of curved tile roofs. Note the missing and displaced “birdstops” that provide an entry path for firebrands.

It was evident that a house's having a wood-shake shingle roof was a very good predictor of whether it survived. To document that observation, two residents, Amy and Oren Patashnik (a computer scientist/mathematician), on Sunday, November 16, 2003, walked through the entire neighborhood, gathering the data used in this section. Each house was classified by roof type: wood-shake shingle (W), curved tile (CT), stone-covered steel (S), flat-tile/concrete (FT), or tar-paper/no-roof (T). Note: "curved tile" is also known as, among other things, Spanish style, Mexican style, and Mediterranean style; this section uses the more descriptive "curved tile" (Figure 1).

It's also worth examining the current status of the CT roofs in LVP1. These roofs are now 25 years old and therefore maintenance is an issue. Many have cracked tiles, missing or dislodged “birdstops”, and gaps between tiles that small firebrands could infiltrate. Figure 1, a picture taken in November 2006, shows one such LVP1 roof. Notice in particular the sizeable gap behind the farthest birdstop, easily big enough to allow firebrand entry. One such birdstop in a different part of that roof was found earlier this year to be harboring a bird's nest. In general the gaps can be significant.

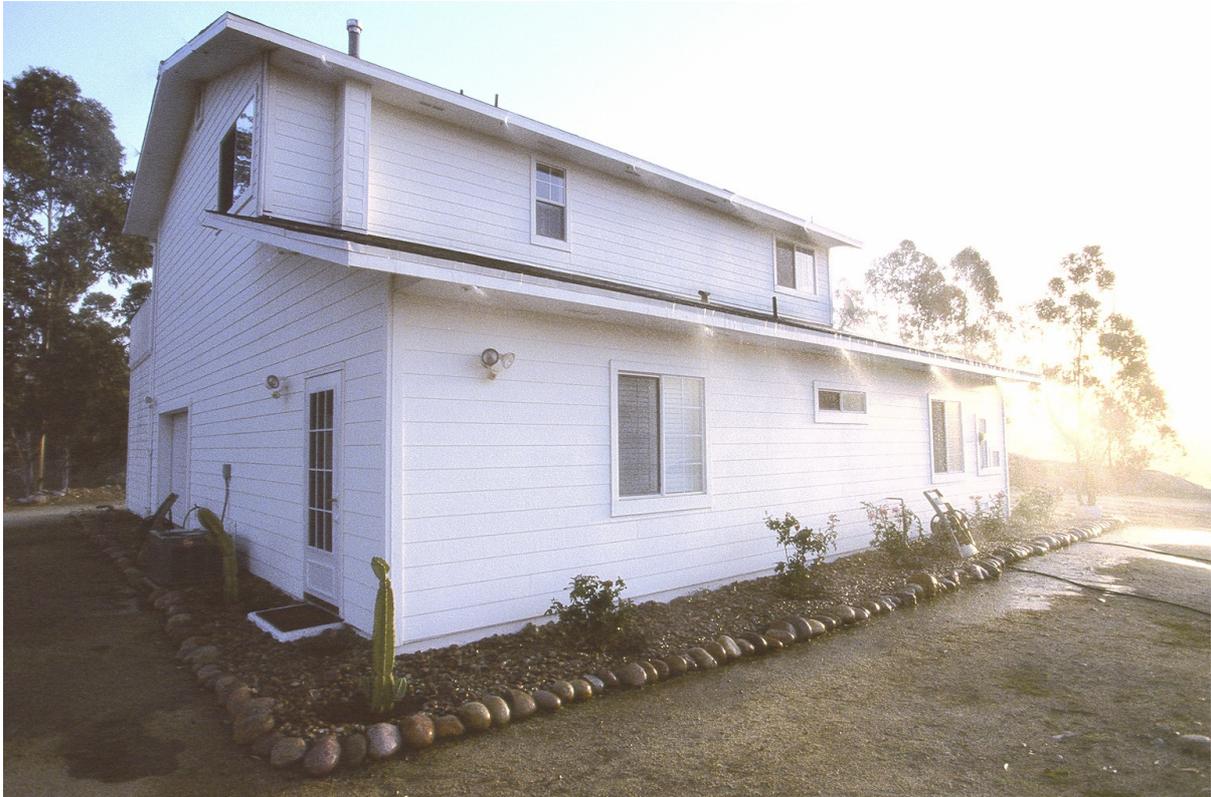
Figure 2. WEEDS in operation

Photo of the WEEDS sprinkler system in operation. 32 nozzles delivering about 4 liters per minute each are directed away from the structure. Photo by Nanette Martin (www.nanettemartin.com).

This system was constructed in 2002, and all backup systems were installed by October 24, 2003. On October 26, 2003, the Cedar fire overran the property. The system was activated prior to evacuation, and all systems performed well. The structure survived the fire, whereas all adjacent properties lost structures. The structure is in a corridor that was deemed hazardous to fire personnel, and no professional fire support was made available until the day after the fire front had passed through. This area suffered a 60% structure loss rate, despite the absence of flammable roofing as a contributing factor.

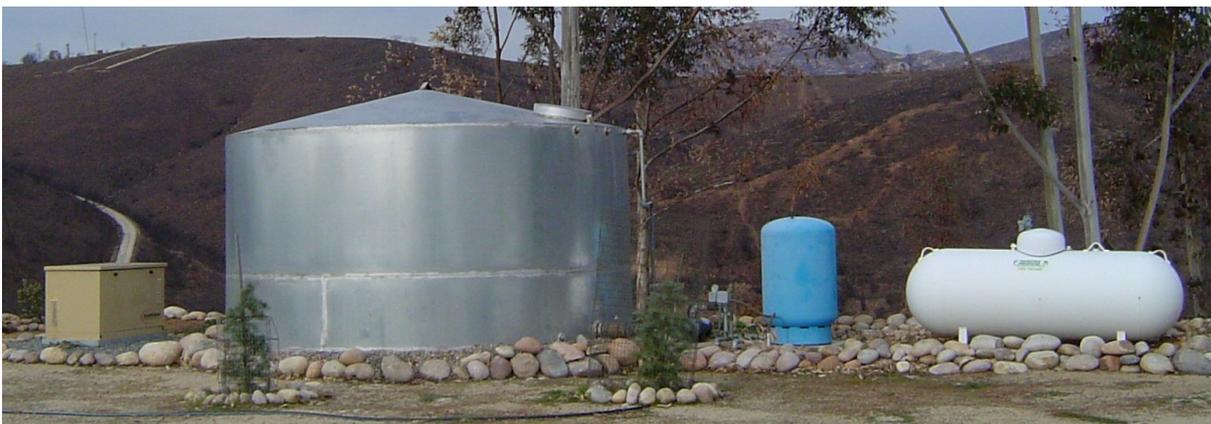
Figure 3. WEEDS support systems

Supply and backup systems for WEEDS include from left to right a 12 kW generator, a 5000 gallon (21 k liter) storage tank, a pump, pressure tank, and propane supply.

The support systems required to supply water under realistic wildland fire conditions are shown in Figure 3.
